## PRODUCT BULLETIN

**PB NO. 102**  
**REV. 0**

**SUBJECT: Camshaft Lobe Wear**  
**Superior 510 & 825 (Inline-Vee) Series Engines**

**PROBLEM** Premature Camshaft Lobe Wear Caused by  
Inadequate Pin to Roller Lubrication

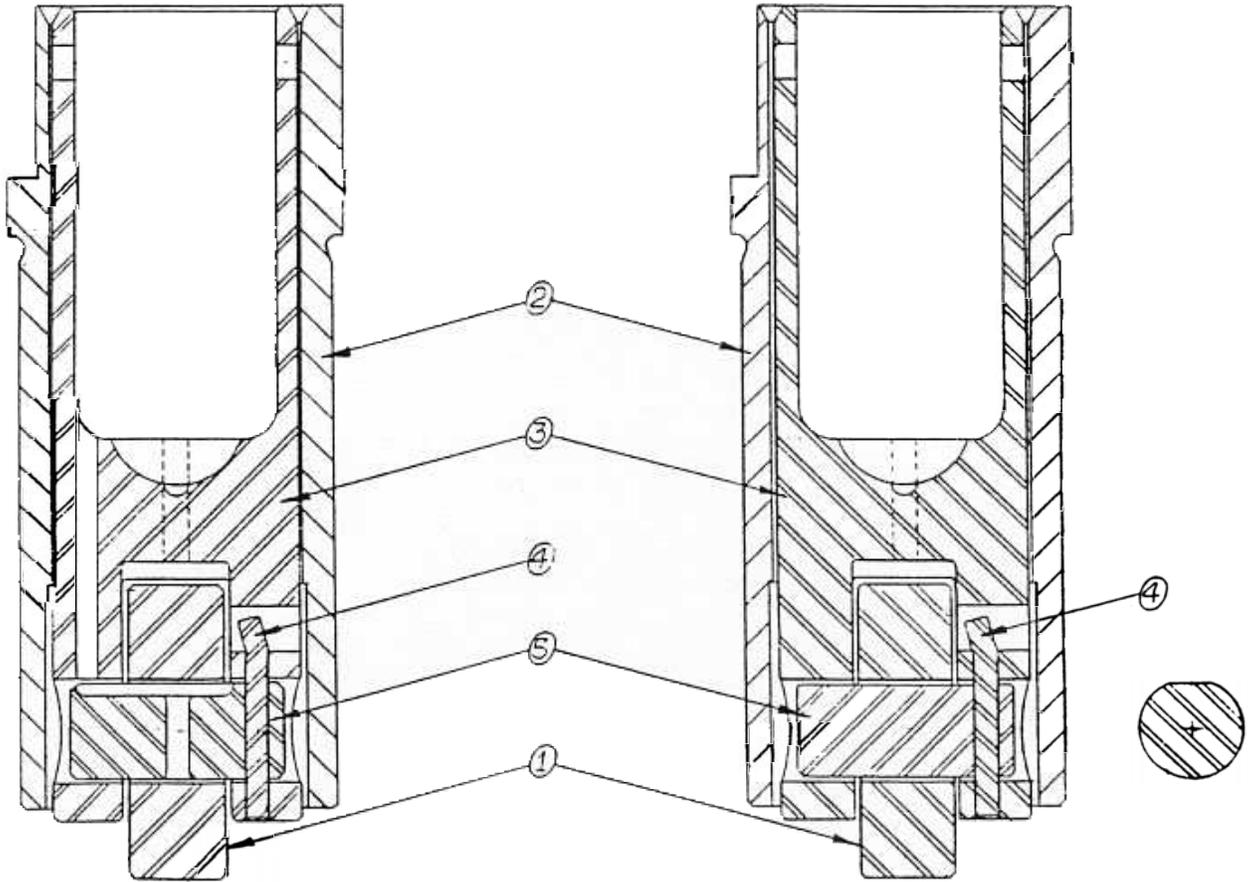
*CAM FOLLOWER ASSEMBLY*  
*— FOR MODEL 510 SUPERIOR ENGINES —*

III. Solution: The solution to the above problems a new **PowerParts**<sup>®</sup> cam follower assembly with the state of the art materials and a design which increases the roller to pin lubrication over 10 times. The attached cross sections, compares the OEM and **PowerParts**<sup>®</sup> assemblies and indicates the design changes which result in proper pin to roller lubrication.
