TECHNICAL BULLETIN

TB NO. 1035

SUBJECT: Reworking VEE Engine Bedplates

TITLE: VEE Thrust Bearing Modification

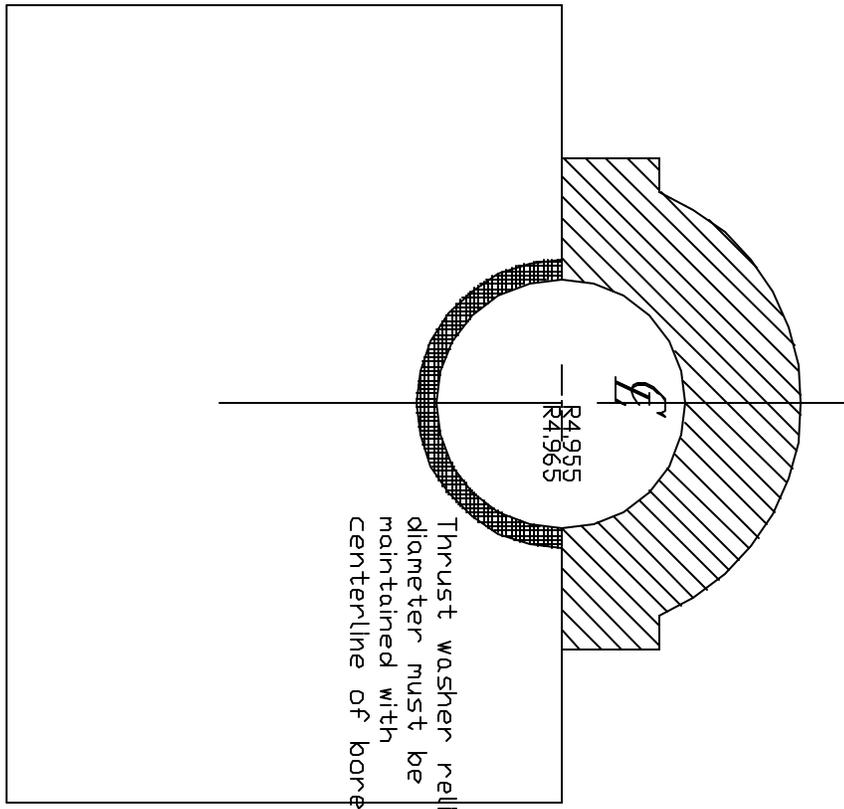
BACK VIEW

Thrust washer relief diameter must be maintained with centerline of bore.
