TECHNICAL BULLETIN

TB NO. 1036

SUBJECT: Upgrade of P-000-253 Rocker-Arm Lever to the New Style Lubrication Design of the P-022-558 Lever.

Affected: All six, eight, twelve and sixteen cylinder Superior 825 series gas engines.

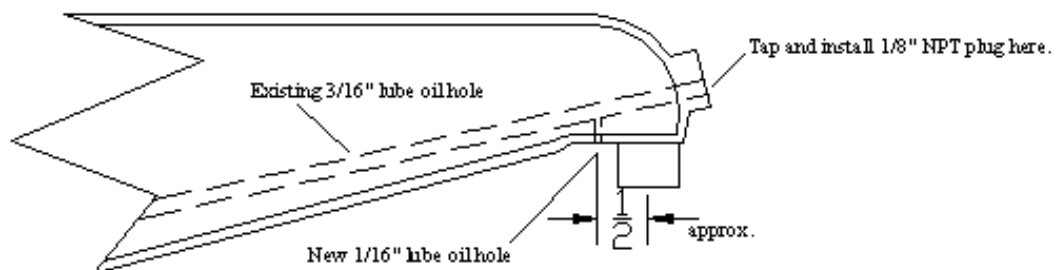
SOLUTION: To improve lubrication of the power valve stems, the following steps should be taken.

Drill a 1/16" hole approximately 1/2" from the center of the hardened tappet surface, through the bottom of the rocker lever. Drill until the 1/16" hole intersects the 3/16" hole that exists from the bushing bore through the end of the rocker lever.

Tap the existing 3/16" end hole, with a 1/8" NPT pipe tap.

Flush all machine debris and install a 1/8" pipe plug in the newly tapped threads. Apply a small amount of 242 Loctite or T271 Staybond to the threads.
