## TECHNICAL BULLETIN

**TB NO. 1040**

**SUBJECT:**            **Revision of Main Bearing Cap on VEE Engines**

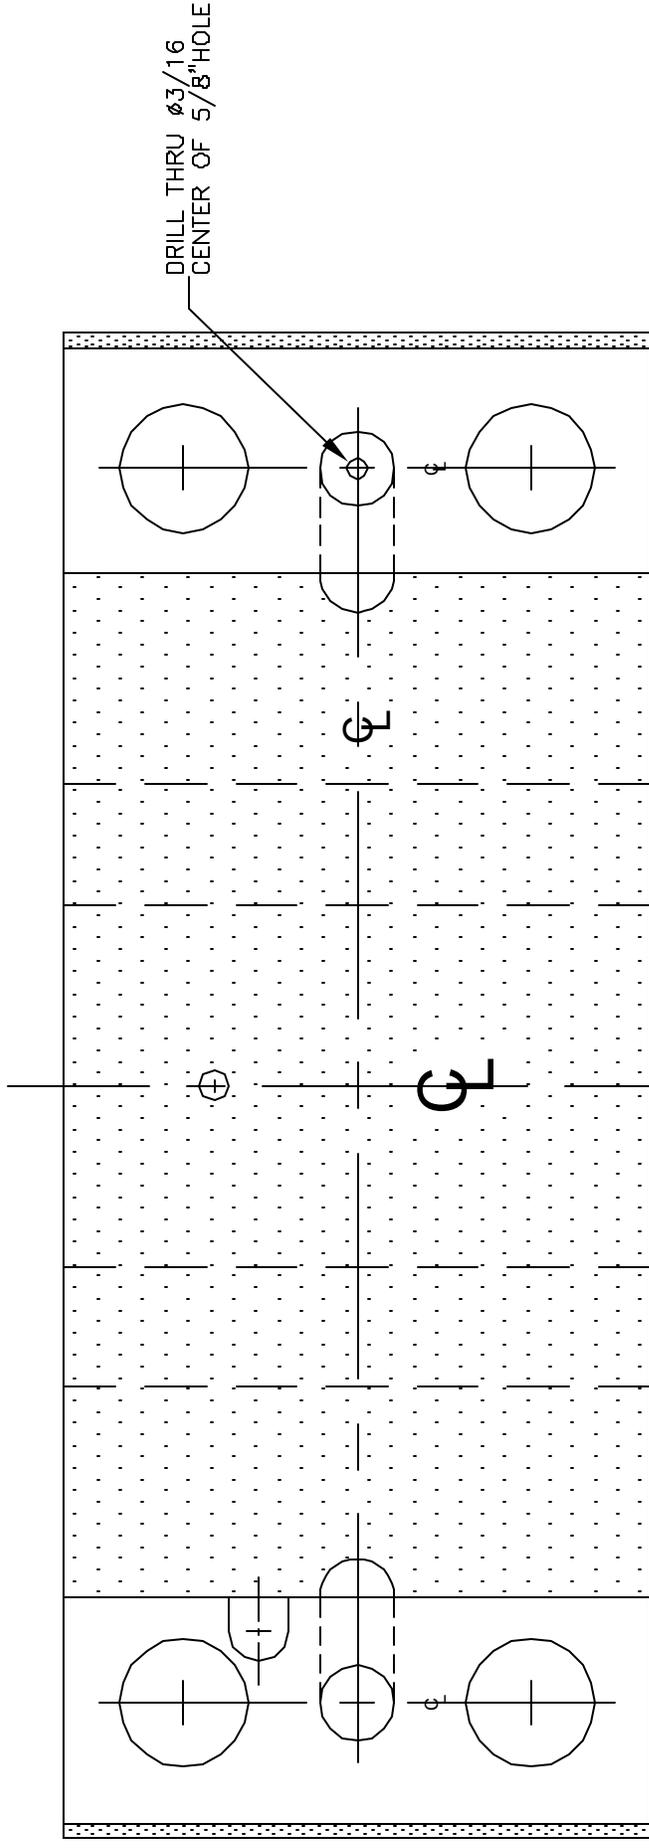
P-033-558-C

**PROBLEM:**            Some reconditioned bedplates and pre-1972 models do not have the center main cap drilled for oil circulation

- DRILL 3/16" VENT HOLE IN THE CENTER MAIN BEARING CAP AS SHOWN.
- VENT HOLE IS TO PROVIDE OIL CIRCULATION THROUGH THE MAIN BEARING TO IMPROVE COOLING & LUBRICATION AT THIS LOCATION. THIS IS NOT NECESSARY ON THE OTHER MAIN BEARING CAPS SINCE THESE BEARINGS HAVE A THROUGH FLOW IN FEEDING COOLING OIL TO THE PISTONS.
- STAMP TOP OF CAP "CENTER MAIN ONLY"

**SOLUTION:**            Modify center main cap for oil vent

Please refer to EnDyn drawing **P-033-558-C** for the proper size and location of the vent hole.
